# Health condition monitoring of insulated joints based on axle box acceleration measurements

Maria Molodova, Maider Oregui, Alfredo Núñez, Zili Li\*, Rolf Dollevoet

Section of Railway Engineering, Faculty of Civil Engineering and Geosciences, Delft University of Technology, Stevinweg 1, 2628 CN Delft, The Netherlands

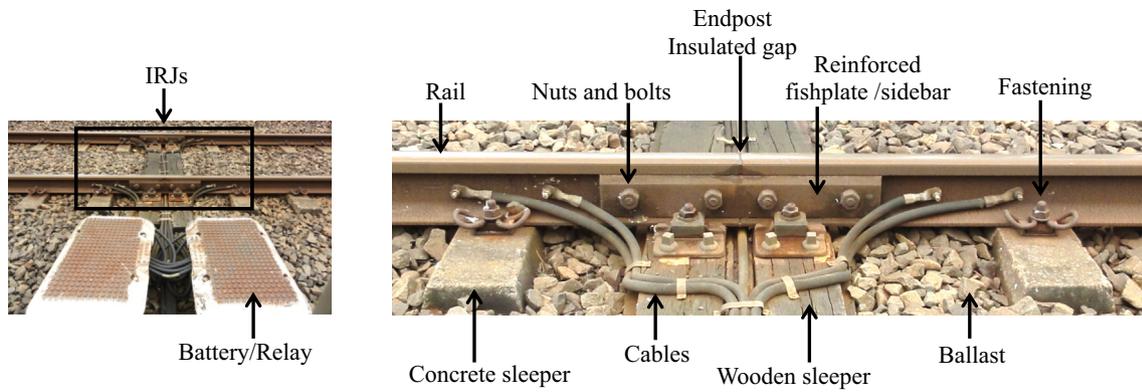
Fig. 1. Picture of an IRJ and its main components.

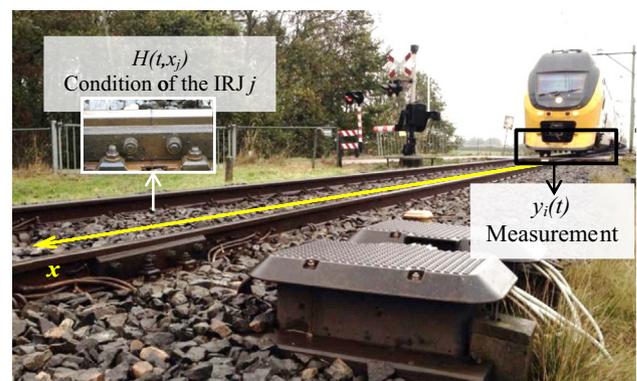
Fig. 2. Track conditions are assessed via signal processing methods using on-board measurements.

The ABA was measured by general purpose accelerometers mounted on the axle boxes of the wheels. Fig. 2 represents a scheme of the whole system IRJ – train. The full set of acceleration measurements for the train  $i$  are in the vector  $a_i(t)$ . The recorded data also included the GPS coordinates  $x_i(t)$  and the train speed  $v_i(t)$  which was around the normal operational speed of the measuring train (100 km/h). The full measurement vector is denoted as  $y_i(t)$ ,  $y_i(t)=[a_i(t) \ x_i(t) \ v_i(t)]$ .

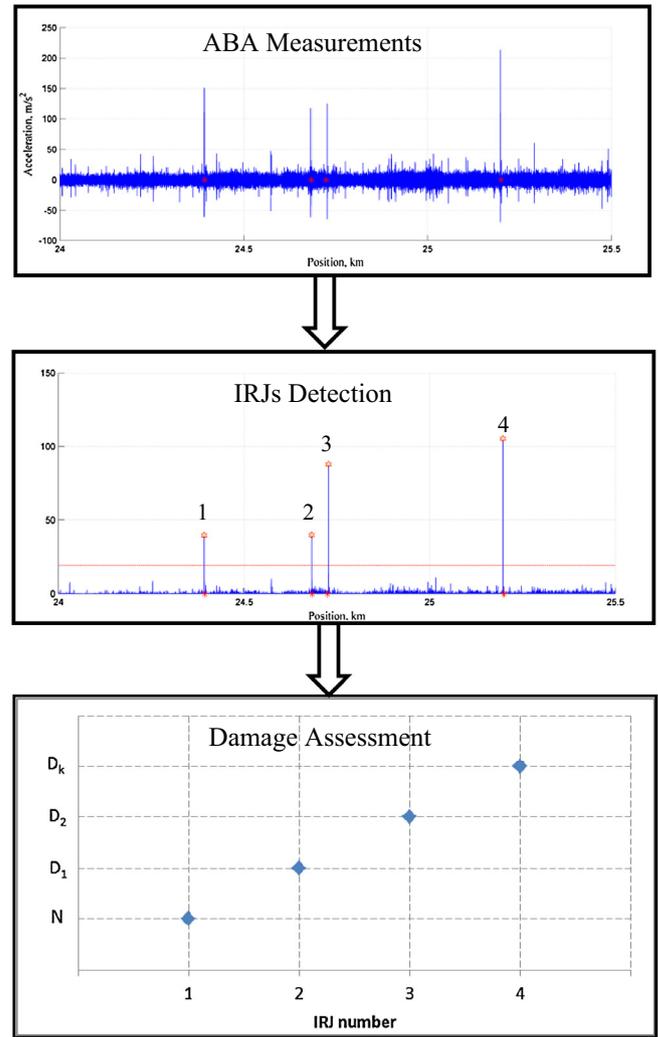
Fig. 3. The health condition monitoring scheme of the IRJs.

In the next sections, the automatic detection algorithm of IRJ based on the wavelet analysis of the ABA signals is presented. Then, to enable the automatic damage assessment of IRJs, the ABA signals at IRJs of different quality  $\{D_1, D_2, D_3\}$  are analysed for an estimation of the relationships between the health of IRJs and ABA characteristics, such as the maximum ABA magnitude  $a_j^{\max}$  and the PSD  $P_{a_i a_i}(f)$ . The process of the IRJ's health condition monitoring is displayed in Fig. 3.

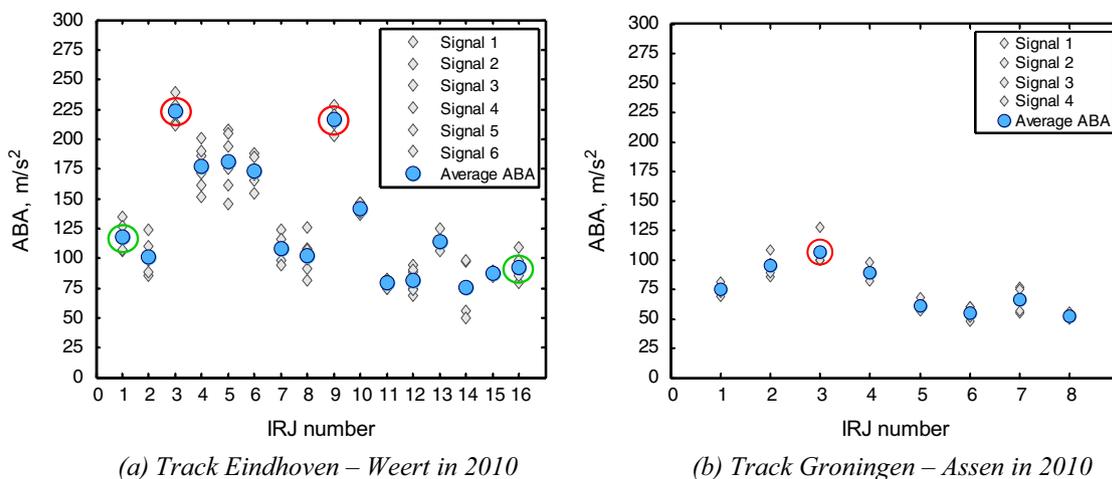
Fig. 4. Local maxima of ABA at IRJs. Blue circles indicate average local maxima, grey diamonds denotes the maximum of each ABA measurement. (For interpretation of the references to colour in this figure legend, the reader is referred to the web version of this article.)

The IRJs are usually characterized by high values of ABA. In Fig. 4, we relate the local maximum ABA to the state of the IRJ from the two tracks. The photos of some of the IRJs of Fig. 4 are presented in Fig. 5. The ABA signals from repeated measurement runs were low-pass filtered with the cut-off frequency of 2 kHz, to include the frequency range typically excited at short wave track defects [24]. The blue circles in Fig. 4 are the average local maximum of six repeated signals on the track Eindhoven–Weert

(Fig. 4a), and four repeated signals on the track Groningen–Assen (Fig. 4b); the range of ABA maximum values was indicated by the grey diamonds.

To study the relationships between the state of IRJs and ABA values we compared two IRJ with high ABA magnitude (IRJs number 3 and number 9 indicated with red circles in Fig. 4a) and two IRJs with comparatively low ABA magnitude (IRJs number 1 and number 16 indicated with green circles in Fig. 4a). As it appeared from the visual inspection of the IRJs, the two IRJs with high ABA magnitudes (above 200 m/s<sup>2</sup>) were indeed in a deteriorated condition: the IRJ number 3 had plastic deformation  $D_1$  on the rail surface caused by the impact at the endpost (Fig. 5c) and the IRJ number 9 had a crack in the fastener  $D_2$  (Fig. 5g and h). As for the IRJs with comparatively low ABA magnitude (below 150 m/s<sup>2</sup>), the IRJ number 1 may be considered as in a good condition (Fig. 5a), since only light deformation of the rail surface is visible. While the IRJ number 16 had a significant gap between the two pieces of the rail, as a result of the loss of insulation material  $D_3$  (Fig. 5j). Thus, the ABA magnitude at IRJs cannot be an indication of  $D_3$ . Therefore, further investigation of the frequency content of ABA is presented in the next section.

In Fig. 4b the ABA on the track Groningen–Assen has less variation in values, than on the track Eindhoven–Weert, with the average local maxima ranging between 50 and 100 m/s<sup>2</sup>. The IRJ with the highest ABA value is number 3, which has moderate degradation of the rail surface  $D_1$  (Fig. 5l).

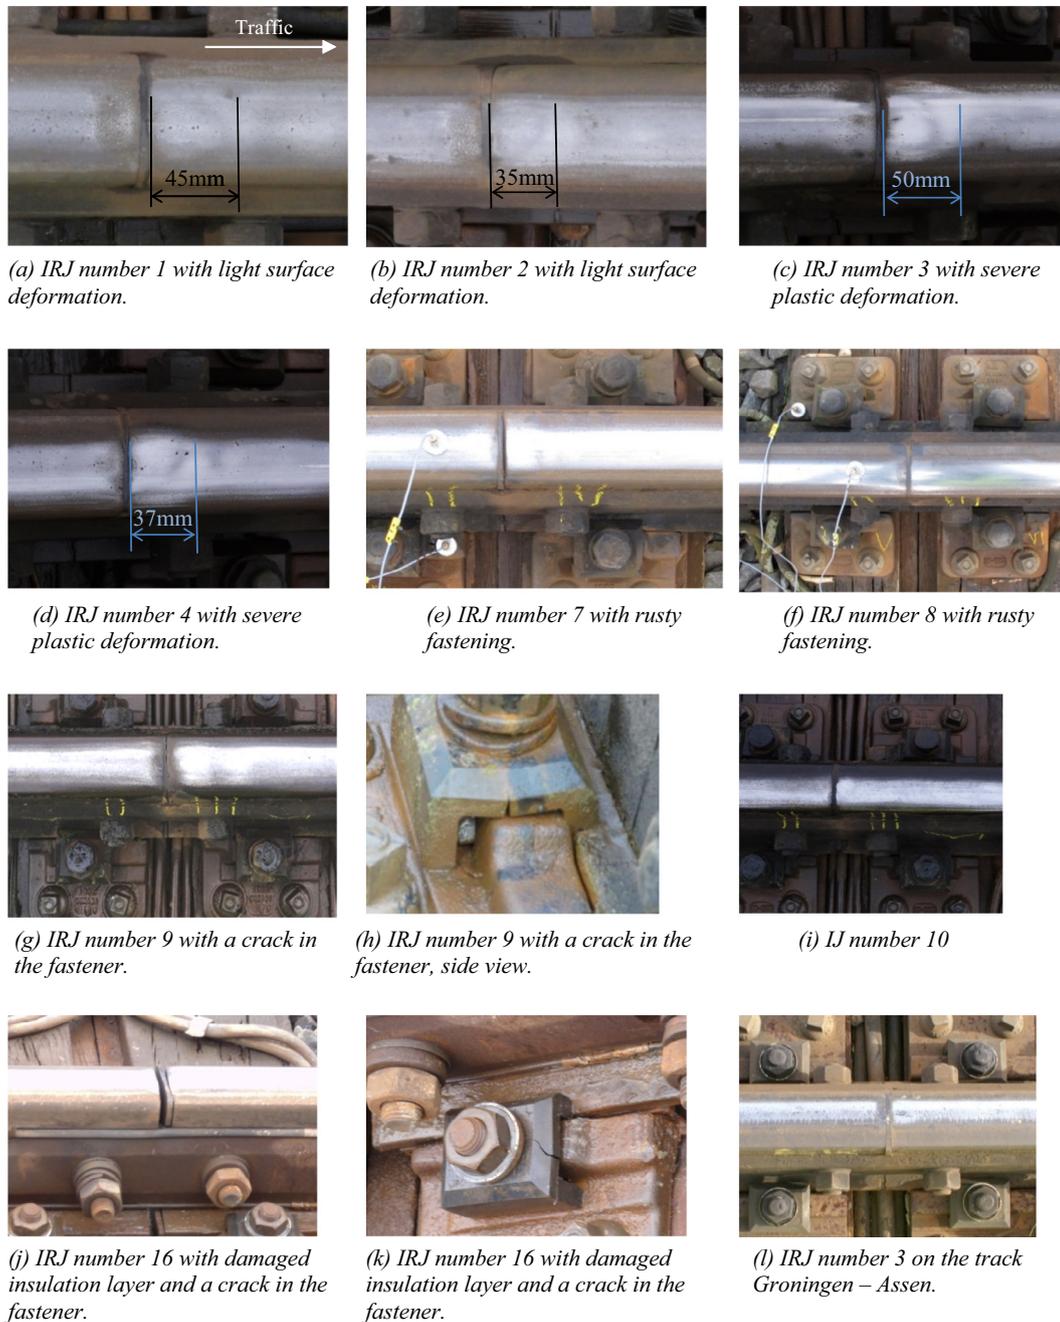
**Fig. 5.** Photos of IRJs in 2010. The photos (a–k) are on the track Eindhoven–Weert with the numbering of IRJ corresponding to Fig. 8a and the photo (l) is on the track Groningen–Assen. The traffic direction in these photos is from left to right.

In this section, four IRJs from the track Eindhoven–Weert (E–W) were investigated, IRJ number 1 and 2 with light plastic deformation (Fig. 5a and b) and the IRJ number 3 and 4 with severe plastic deformation of the rail surface (Fig. 5c and d). The plastic deformation is caused by the impact occurring after the gap and has a typical wavelength of about 35–50 mm [27]. Since IRJ number 2 with light surface deformation did not have any other visible damage at the fastener and insulation layer, it will also be used for comparison in the next sections as a reference IRJ in normal condition.

In this section the IRJ with a crack in the fastener was investigated ( $D_2$ ). That is IRJ number 9 in Fig. 5g and h. The dynamic

responses at this IRJ were compared to the reference IRJ without visible damage in the fastener (Fig. 5b).

In this section, an IRJ number 16 with two types of damage was investigated: with damaged insulation layer (Fig. 5j) and the crack in the fastener (Fig. 5k). The damage of the fastener for this IRJ was similar to the one of IRJ number 9 in Fig. 5h.

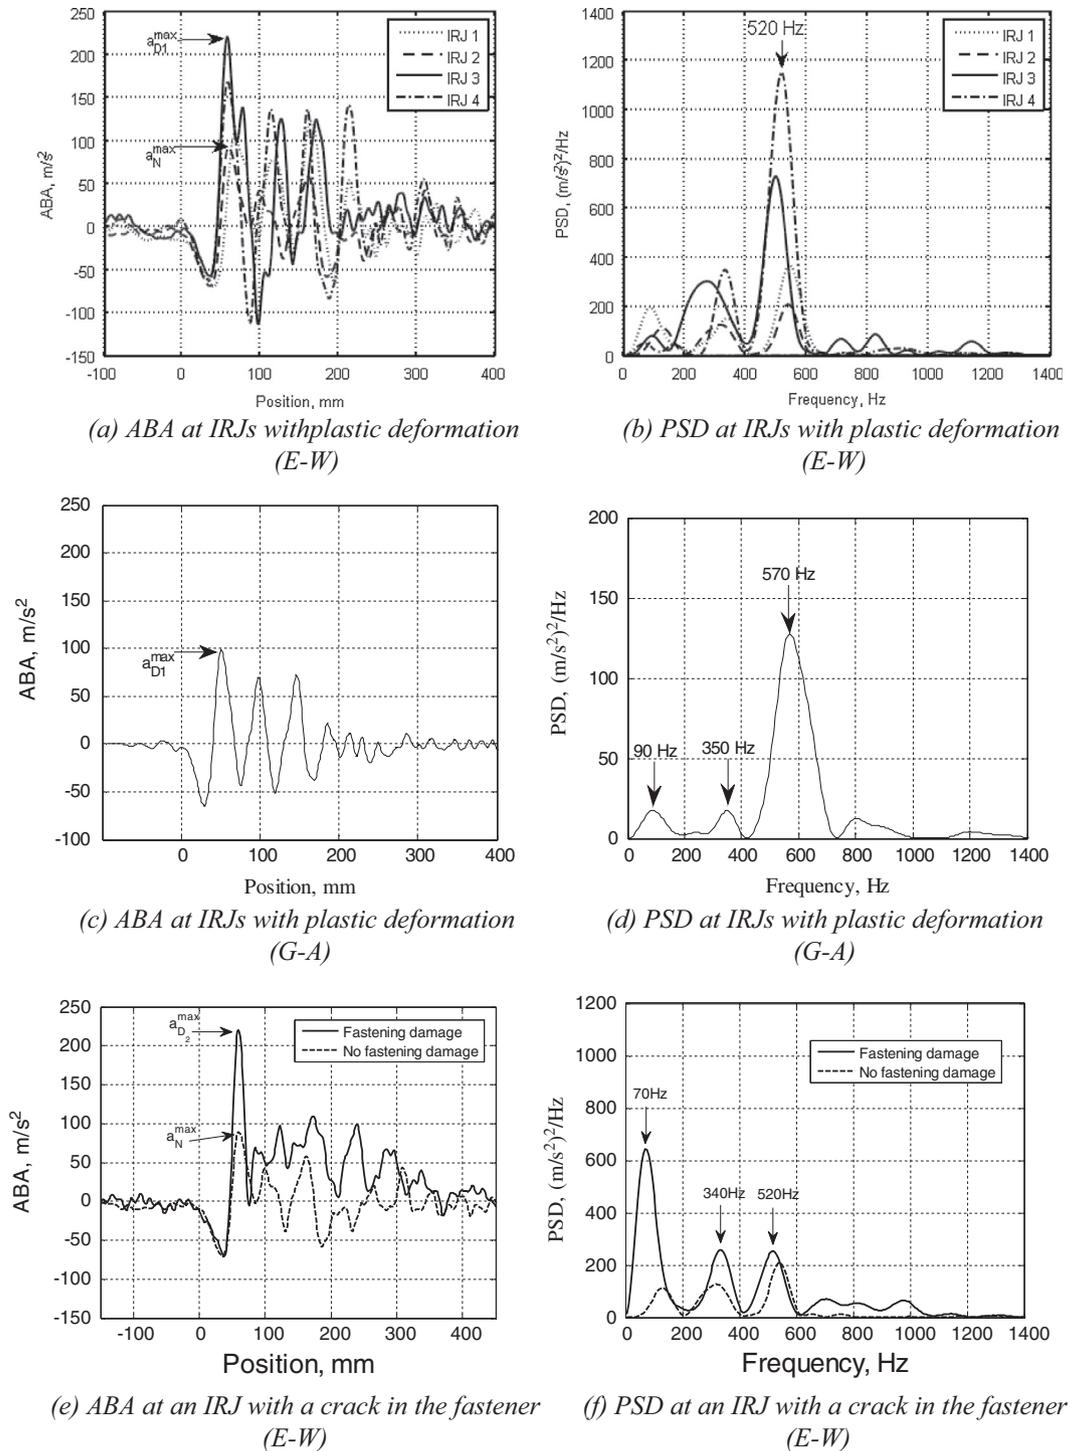
Fig. 6. ABA and PSD at various IRJs, October 2010.

The ABA measured at these four IRJs are shown in Fig. 6a. The ABA signals for each IRJ in this section and the next sections are the average signals out of four repetitive ABA signals, filtered with the low-pass Butterworth filter with a cut-off frequency of 2 kHz. The averaging and the filtering were done in order to reduce the noise in the measured signals. The ABA signals at these IRJs had a wavelength of about 50 mm. The local maximum ABA was the highest for IRJ number 3 ( $a_{D_1}^{\max} = 220 \text{ m/s}^2$ ) and about 2.4 times higher than ABA at the IRJ number 2 in normal condition ( $a_N^{\max} = 91 \text{ m/s}^2$ ). The plastic deformation at IRJ number 3 has the longest wavelength among these four IRJ's, 50 mm (Fig. 5c).

The PSD at these IRJs is shown in Fig. 6b. The major peaks for the IRJs fall into the following frequency ranges: 70–170 Hz, 270–350 Hz and 500–550 Hz. The largest peak is at 520 Hz for IRJ

number 4 with severe rail surface plastic deformation. The peak that appears in each ABA signal in the frequency range between 500 Hz and 550 Hz might be related to the plastic deformation of the rail surface. As the train speed was 100 km/h the vibrations in the range of 500–550 Hz are related to the wavelength of the wave pattern of 50–55 mm of the rail surface. When the wave pattern on the rail surface starts to develop, the vibrations in the range of 500–550 Hz work as a positive feedback mechanism. That is, the wave pattern of 50–55 mm increases the vibrations at 500–550 Hz, and higher level of vibrations at this frequency causes further plastic deformation with a wavelength of 50–55 mm.

IRJ number 3 has the longest wavelength of plastic deformation (50 mm) and the highest local maximum ABA compared to the other three IRJs in Fig. 6a. However, the PSD at 500–550 Hz for

IRJ number 3 was not the highest among these IRJs, because the energy was distributed over a range of frequencies (270 Hz, 730 Hz, 830 Hz, 1150 Hz, see Fig. 6b). This can indicate that there is damage in other components of IRJ number 3 besides plastic deformation of the rail surface (sleeper, fastener, etc.). Thus, there is no direct correlation between degree of plastic deformation of the rail surface and PSD at 500–550 Hz. However, the combination of high ABA magnitudes and high values of PSD at 500–550 Hz can qualitatively indicate the plastic deformation. For this reason in Section 4.2 we use both ABA magnitude and PSD to make a conclusion about damage state.

Fig. 6c presents the ABA measured at IRJs 3 from the track Groningen–Assen (G–A), see photo in Fig. 5l. The ABA signal at this IRJs had a wavelength of about 50 mm. The local maximum ABA was  $a_{D1}^{\max} = 100 \text{ m/s}^2$ , which is quite close to the normal condition ( $a_N^{\max} = 91 \text{ m/s}^2$ ). The PSD at these IRJs is shown in Fig. 6d. There major peaks for this IRJ are 90 Hz, 350 Hz and 570 Hz, which is consistent with the frequencies in Fig. 6b.

The ABA at the IRJ with a crack in the fastener is shown in Fig. 6e (solid line) together with the reference IRJ (dashed line). The ABA signal at this IRJ has a high peak of about  $a_{D_2}^{\max} = 220 \text{ m/s}^2$ . This peak is also related to high contact force, which caused the deformation of the rail surface, visible in Fig. 5g as a broadened shiny wavy running band after the gap. It can also be observed in Fig. 6e that the ABA magnitude of the IRJ number 9 is elevated compared to the reference one.

The PSD at the IRJ with a crack in the fastener is presented in Fig. 6f. The major peak for an IRJ with a crack in the fastener is at 70 Hz, and the other two peaks at 340 Hz and 520 Hz are similar to the peaks of the reference IRJ. The frequency at 70 Hz is probably related to the change in the stiffness of the fastening caused by the crack. This frequency might be responsible for the higher level of vibration after the gap.

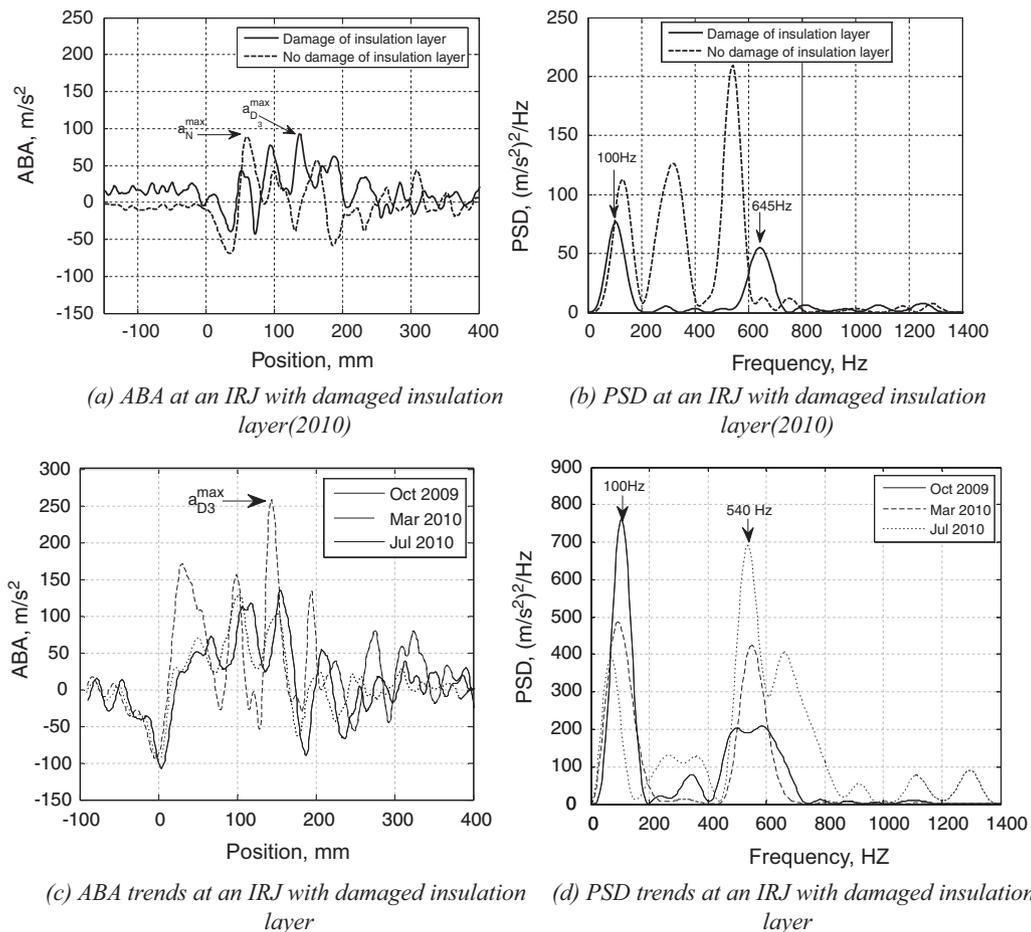
Fig. 7. ABA and PSD at an IRJ with damaged insulation layer, track Eindhoven–Weert.

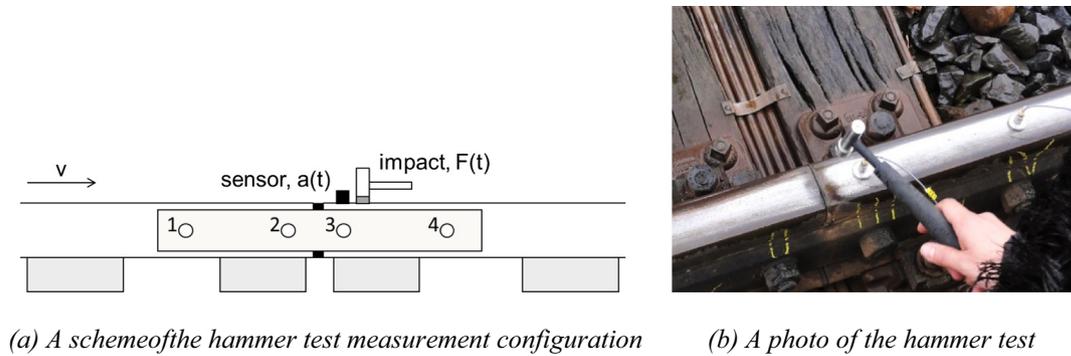
Fig. 8. The hammer test measurement configuration on an IRJ.

Hammer test measurements are widely used to characterize the dynamic behaviour of railway tracks [7,8,26]. By examining the frequency response measured via the hammer test, insight into the condition of the track can be gained [32,12,25]. A schematic representation of the hammer test is shown in Fig. 8. During the hammer test the rail is excited with a hammer and the track response is measured with accelerometers at the location of interest. The excitation force is measured with a force sensor. The measurement configuration in this study included the response measured with a unidirectional accelerometer placed on the top of the rail above the third bolt (Fig. 8) and vertical excitation of the rail close to the measurement location.

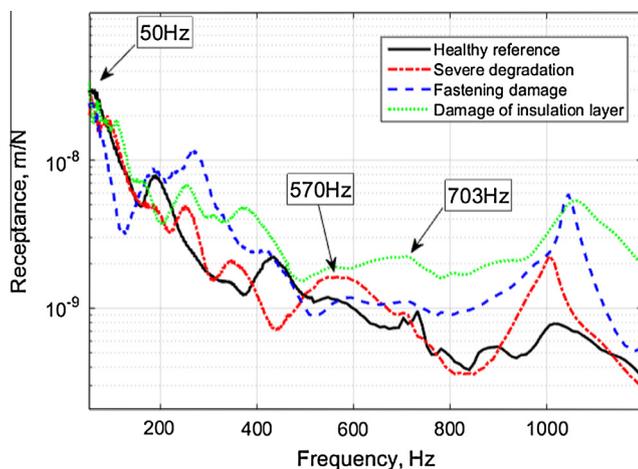
Fig. 9. Receptance functions at the investigated IRJs.

Fig. 9 presents the calculated receptance functions of the nominal and damaged IRJs studied in Section 4.2. For the IRJ with light surface deformation the following peaks were observed: 190 Hz, 350 Hz, 430 Hz, 560 Hz, 730 Hz, 900 Hz and 1006 Hz. Some of

them (190 Hz, 350 Hz, and 560 Hz) agree with the results from the ABA analysis. For the IRJ with severe plastic deformation, there are peaks at 80 Hz, 190 Hz, 250 Hz and 570 Hz that agree well with the results from the ABA measurements. The other two peaks, at 350 Hz and 1006 Hz were not clearly observed in the ABA measurements. For the IRJ with a crack in the fastener the peaks in the receptance function were at about 50 Hz, 190 Hz, 270 Hz, 420 Hz, 580 Hz and 1045 Hz. The peak at about 50 Hz agrees with the major peak at 70 Hz from the ABA analysis; the peaks at about 270 Hz and about 580 Hz correspond more or less to the peaks observed in the ABA at 340 Hz and 520 Hz. The major peaks observed in the receptance function for the IRJ with a damaged insulation layer were at 107 Hz, 250 Hz, 370 Hz, 703 Hz and 1055 Hz. The peaks at 107 Hz and 703 Hz agree with those at 100 Hz and 645 Hz observed in the ABA analysis.

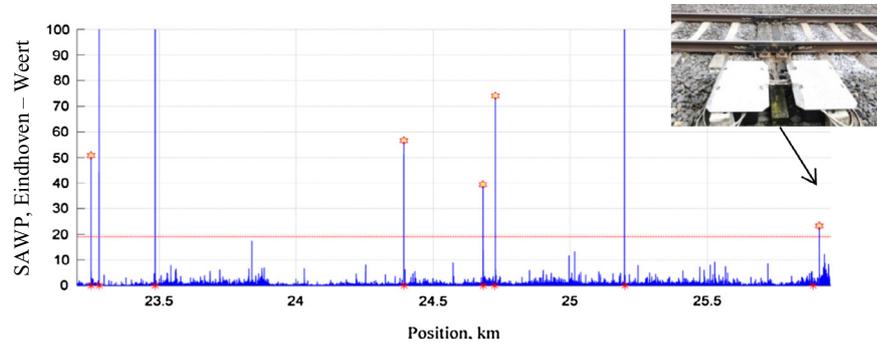
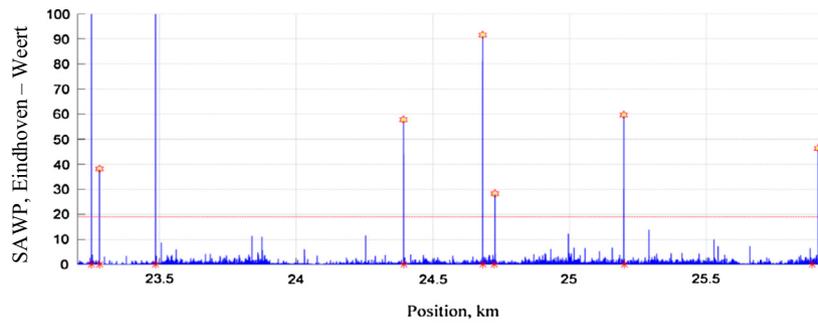
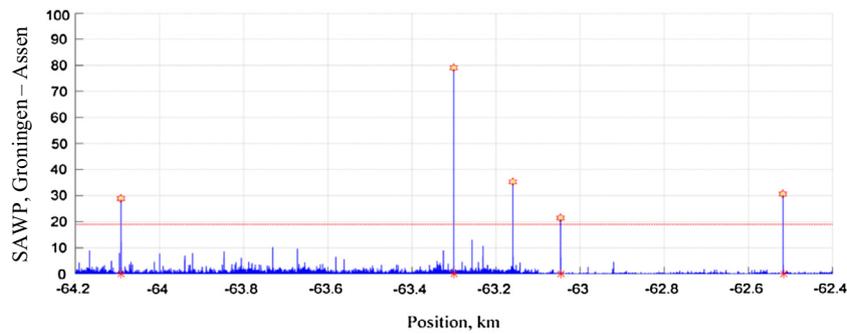
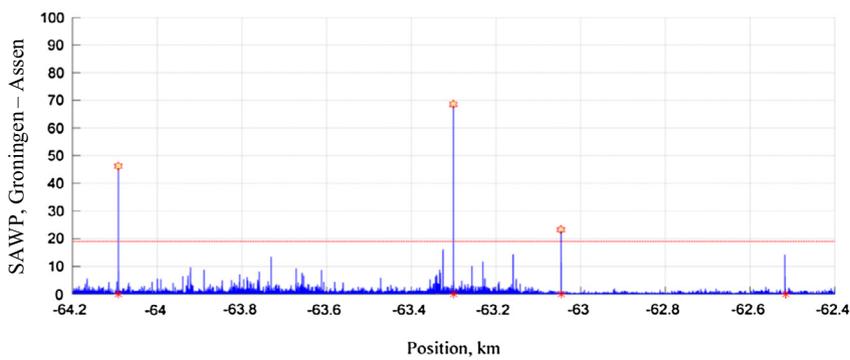
Fig. 10. Detection of IRJs.

(a) Track Eindhoven – Weert, right rail

(b) Track Eindhoven – Weert, left rail

(c) Track Groningen – Assen, right rail

(d) Track Groningen – Assen, left rail

Fig. 10a and b shows the calculated SAWP functions for right and left rails on a section of this track with 8 IRJ's locations, marked with red asterisks. The detection resulted in 77 predicted locations, with 62 of them being correct; 13 locations have been missed and 15 locations were falsely predicted. The hit rate of this detection is 83% and the false alarm rate is 19%.

Fig. 10c and d presents the prediction for another track, Groningen–Assen. The length of the investigated track was 2.2 km with 4 IRJ's locations in total. One of the IRJs at position  $-62.5$  km on the left rail was missed by the automatic detection. However, this location was detected from the signal on the other rail, and thus, by combination of the signals from both rails all the IRJs can be detected. In Fig. 10c there is also one rail defect at  $-63.160$  km, which was falsely detected as an IRJ. This is an artificial rail surface defect, which was made for another research [24] by removing a thin layer of the material on the rail head. Since this artificial defect

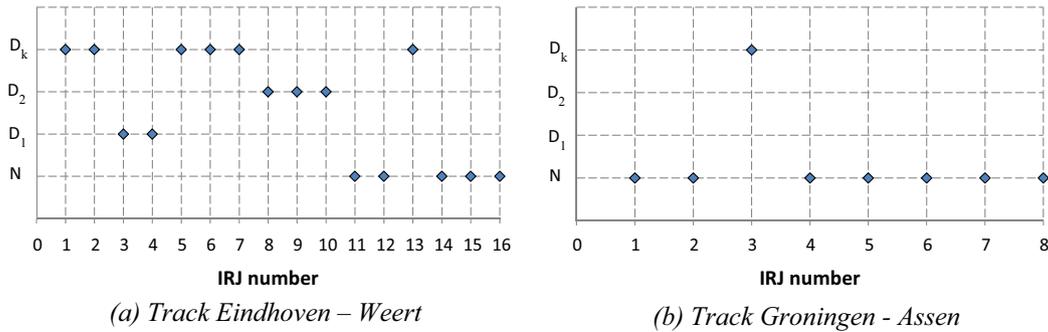
**Fig. 11.** Assessment of IRJs health condition:  $N$  – normal condition,  $D_1$  – plastic deformation,  $D_2$  – fastener damage,  $D_k$  – the health condition is uncertain.

IRJ analysis presented in Section 4. The normal health condition is characterized by low ABA magnitude ( $a_N^{\max} < 100 \text{ m/s}^2$ ) and low PSD values ( $P_{a_N a_N} ([70; 100]) < 200 \text{ (m/s}^2\text{)}^2/\text{Hz}$ ,  $P_{a_N a_N} ([520; 570]) < 400 \text{ (m/s}^2\text{)}^2/\text{Hz}$ ). The IRJs with severe plastic deformation of the rail surface are characterized by high ABA values ( $a_{D_1}^{\max} > 100 \text{ m/s}^2$ ), and high PSD values around 520–570 Hz ( $P_{a_{D_1} a_{D_1}} ([520; 570]) > 400 \text{ (m/s}^2\text{)}^2/\text{Hz}$ ). The IRJs with fastener damage are characterized by high ABA values ( $a_{D_2}^{\max} > 100 \text{ m/s}^2$ ), and high PSD values around 70–100 Hz ( $P_{a_{D_2} a_{D_2}} ([70; 100]) > 200 \text{ (m/s}^2\text{)}^2/\text{Hz}$ ).
